Study on tool wear and workpiece surface integrity following drilling of CFRP laminates with variable feed rate strategy

4th CIRP Conference on Surface Integrity (CSI 2018)

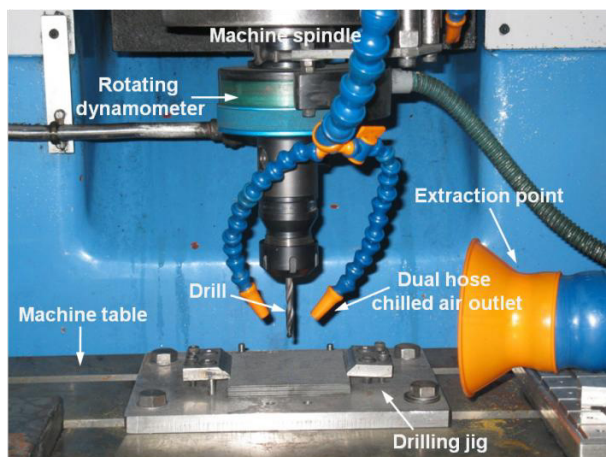
Fig. 2. Experimental drilling setup in Matsuura FX-5.

Trials were carried out on a Matsuura FX-5 vertical high speed machining centre with a maximum spindle rotational speed of 20,000 rpm rated at 15 kW. The machining centre was fitted with a Renishaw probe and tool length setter as well as a dust extraction system capable of removing particles down to 0.3 µm. Fig. 2 shows the experimental setup on the Matsuura FX-5. Chilled air (~8°C) was generated and delivered by a Nex-Flow vortex tube at a pressure of 0.4 bar. Thrust force and torque were measured using a Kistler 9123B 4-component piezoelectric rotating dynamometer mounted on the machine spindle via a quick change toolholder. The force signals were relayed to a PC installed with Dynoware software for analysis via a Kistler type 5221A stator and type

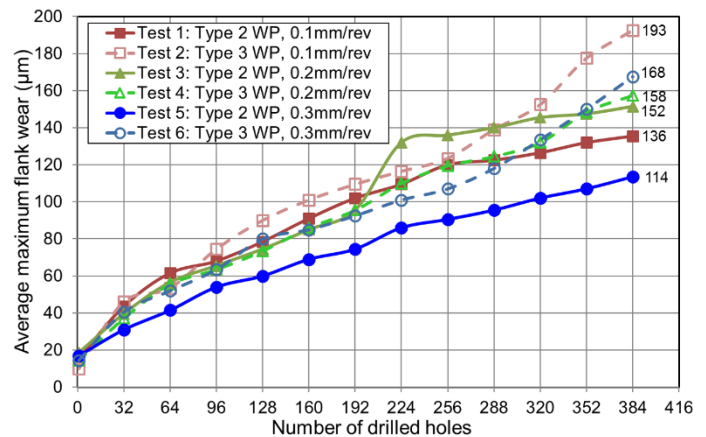
Fig. 3. Flank wear curves for all tests against number of drilled holes.

Fig. 3 details the evolution of tool flank wear against number of holes drilled for all tests. All of the drills produced 384 holes, with flank wear ranging between 114 μm (Test 5) and 193 μm (Test 2). Tool wear at test cessation was typically lower by up to ~41% when drilling the Type 2 laminates and operating at higher feed rates. This was due in part to the larger thickness of the Type 3 workpieces as well as the shorter tool-workpiece contact time. It was observed that abrasion (prior to removal of coating layer) and delamination of the CVD-diamond coating were the principal tool wear modes, as shown in the wear scar micrographs from Tests 2 and 5 in Fig. 4.

Analysis of variance (ANOVA) of the data revealed that none of the main factors were statistical significant with respect to tool wear, although this was possibly due to the fact

that the majority of tool-workpiece contact time (~70–88%) was confined to the final 2 mm of the hole when feed rate was reduced to 0.01 mm/rev. This may also have contributed to the relatively high residual level (~75%), with workpiece material having a percentage contribution ratio (PCR) of 24.54% while the corresponding PCR for primary feed rate was negligible.

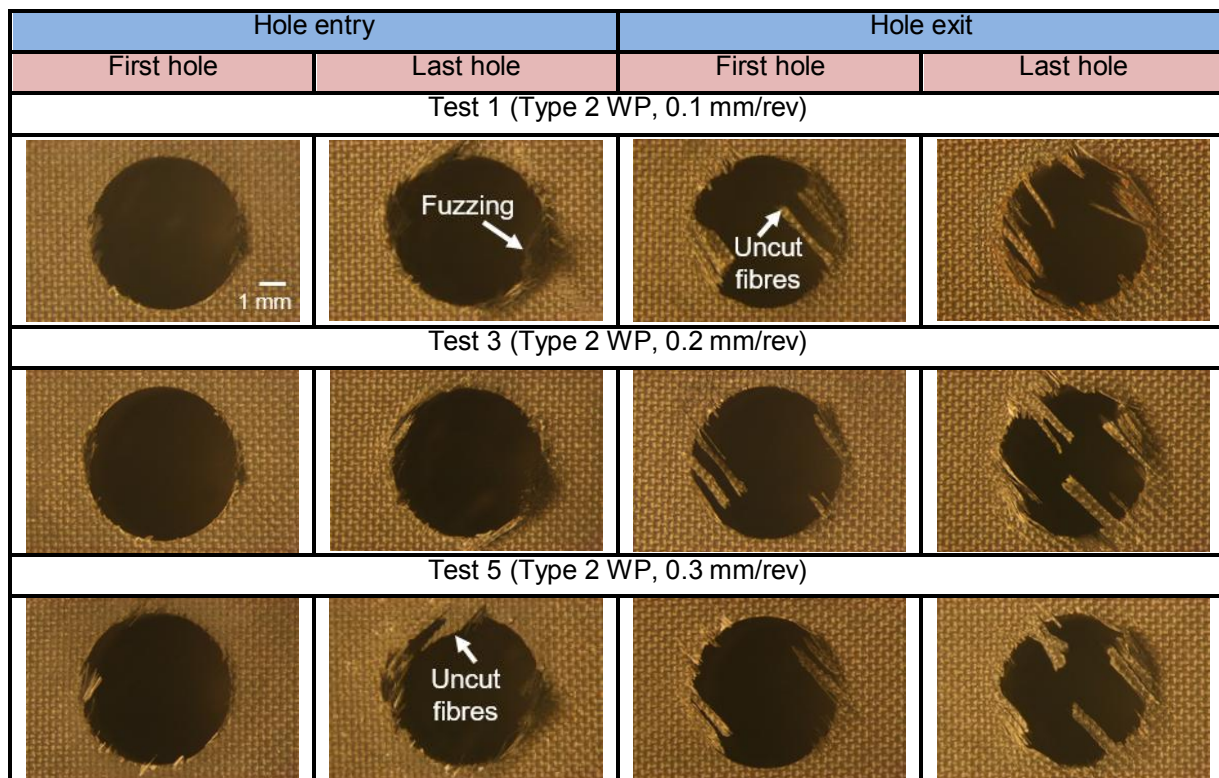
Fig. 5. Hole entry and exit quality of the first and last holes in tests involving Type 2 workpiece material.

Fig. 5 shows micrographs of hole entry and exit for the first and last holes drilled in trials involving the Type 2 workpiece materials (Tests 1, 3 and 5). In terms of hole entry quality, minor damage in the form of fuzzing and limited uncut fibres was observed in the first holes drilled, while greater levels of fuzzing, uncut fibres and delamination were apparent for the last holes drilled, irrespective of primary feed rate and workpiece type. Despite application of the decreased feed rate (0.01 mm/rev) strategy for the final 2 mm of the workpiece, the damage at hole exit was generally similar or more pronounced than the corresponding entry location, see Fig. 5. However, a reduction in exit damage was evident when compared to holes drilled at a constant feed rate of 0.1 mm/rev [14].

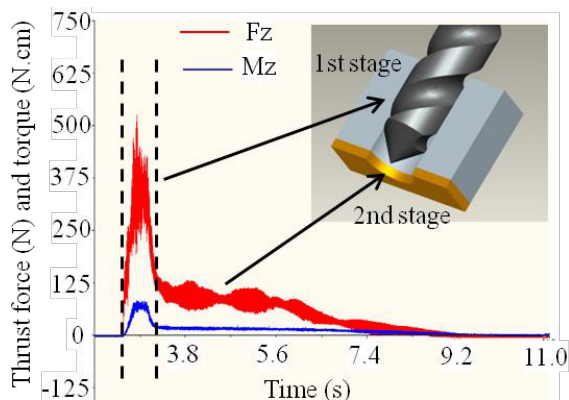
Fig. 6. Typical force and torque profile at the last hole (hole 384) drilled.

Fig. 6 shows the typical thrust force and torque profiles obtained when drilling the last hole in each test. Both parameters increased rapidly during the first stage of drilling (primary feed rates of 0.1–0.3 mm/rev), with thrust force and torque peaking at 591 N and 111 N.cm respectively in Test 6, but subsequently dropped by up to ~80% in the second stage of operation where feed rate was considerably reduced (0.01 mm/rev). Thrust force increased by ~98–155% over the test duration when drilling the Type 3 composite while the corresponding rise was limited to ~56–67% in trials involving the Type 2 material.

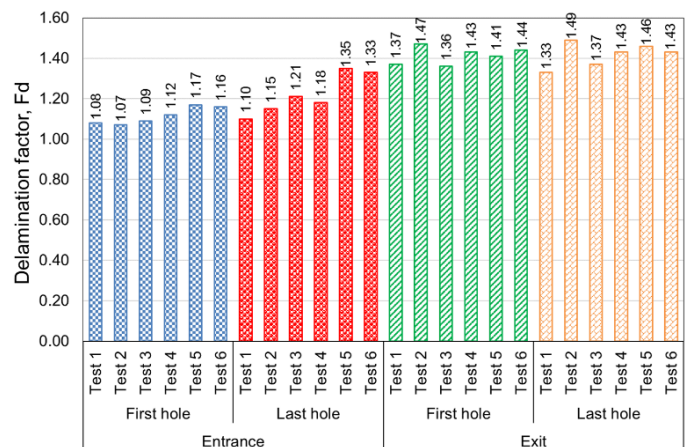
Fig. 7. Delamination factor at hole entry and exit for first and last holes drilled in all trials.

The calculated delamination factors at hole entry and exit positions for the first and last hole drilled in each test are detailed in Fig. 7. In general, F_d was found to be greater (by up to 0.18) at test cessation compared with the first hole drilled for both entrance and exit locations. Delamination factor values at hole entrance generally increased with feed rate with a maximum of 1.35 observed in Test 5 (Type 2, 0.3 mm/rev). For the exit delamination factor, Type 2 workpiece normally produced lower values (up to 0.16 lower) than the Type 3 material, except for the last hole drilled when operating at 0.3 mm/rev (Test 5). Understandably, the influence of varying primary feed rate on exit delamination factor exhibited no apparent trend. According to the associated ANOVA, feed rate was found to be a statistically significant factor (at the 5% level) affecting the entrance F_d of the first hole drilled with a PCR of 87.9%, which was in agreement with the observations of other researchers [7].

There was limited discrepancy between exit F_d values of the first and last holes drilled, which suggests that the lower feed rate used had a more dominant effect than tool wear level on hole exit damage.

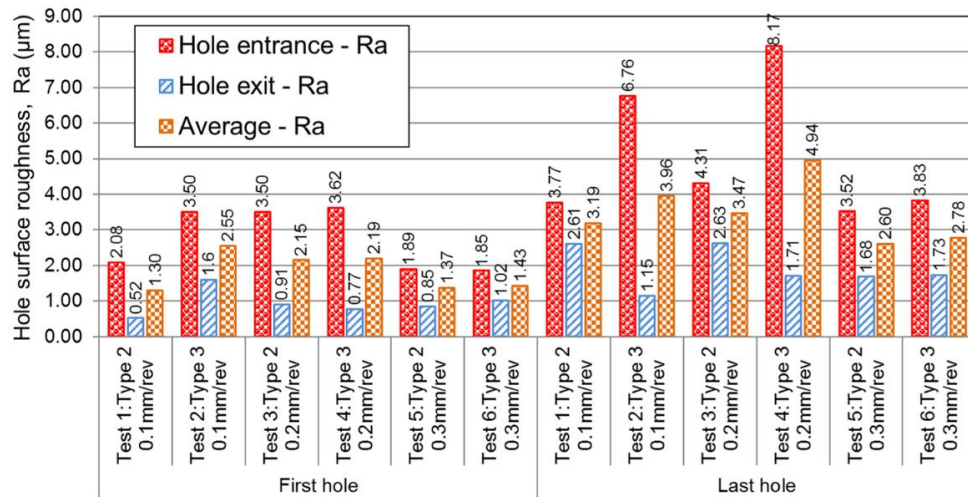
Fig. 8. Surface roughness (Ra) of hole entry and exit section of the first and last holes drilled in all tests.

Fig. 8 outlines the hole surface roughness (R_a) values measured at the entry and exit positions of both the first and last holes drilled in all tests. In general, the roughness values were typically higher in Type 3 workpieces (Tests 2, 4 and 6) compared to the Type 2 configuration machined at equivalent feed rate levels. This was due to the larger number of plies orientated at 135° in the former (14).

Increasing feed rate from 0.1 to 0.3 mm/rev led to lower surface roughness (by ~44% in terms of average Ra) in all of the first holes drilled in Type 3 laminates, which was attributed to the decrease in tool wear when operating at higher feed rates, as a result of the shorter drill-workpiece interaction period. Conversely, there was no apparent correlation between the hole surface roughness and feed rate for the last holes drilled, possibly due to the comparatively high levels of tool wear at test cessation. Furthermore, the roughness measured in the vicinity of the hole exit location was consistently lower (by up to ~80%) than the entrance section, probably due to a ‘ploughing’/‘polishing’ effect when operating at the extremely low feed rate of 0.01 mm/rev.

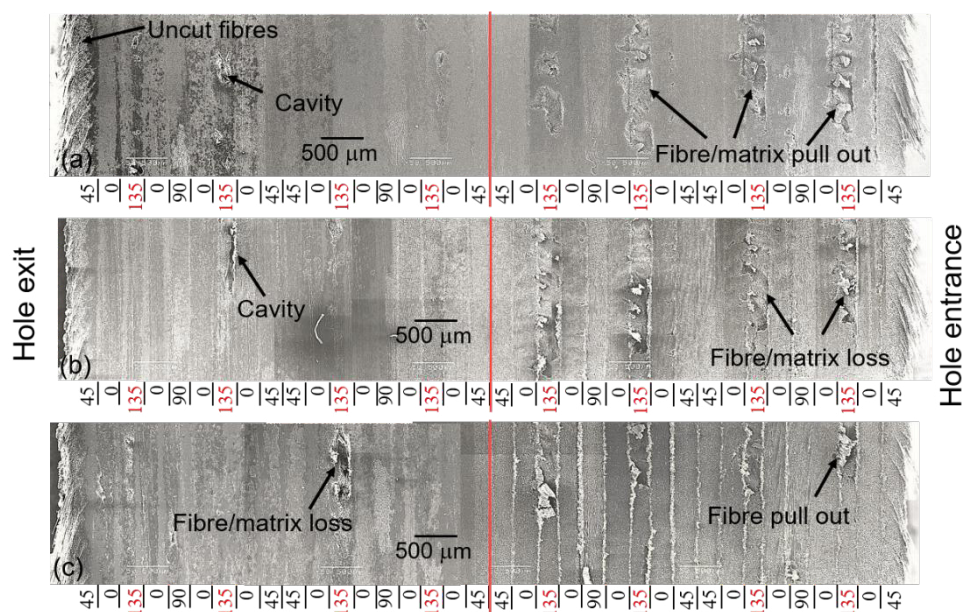
Fig. 9. SEM micrographs of hole surfaces for the first hole in (a) Test 1 (0.1 mm/rev), (b) Test 3 (0.2 mm/rev) and (c) Test 5 (0.3 mm/rev).

Fig. 9 shows SEM micrographs of the machined surfaces for the first holes drilled in Tests 1, 3 and 5 involving the Type 2 workpieces. Defects in the form of fibre and matrix

loss/void formation were evident particularly in the 135° direction plies around the vicinity of the hole entry regardless of the primary feed rate level (0.1-0.3 mm/rev) and despite the drills being in the new condition. Several other researchers have also reported that damage was typically severe in plies orientated at 135° due to the cutting mechanism being dominated by shearing, leading to macro fracture of the fibres [15-16]. In contrast, surfaces with limited flaws were observed near the hole exit due to the lower feed rate (0.01 mm/rev) employed over the final 2 mm of drilling. Considerable deterioration in surface quality over the entire hole however was visible at test cessation; see Fig. 10. Here, reducing feed rate to 0.01 mm/rev near the hole exit provided no appreciable benefits, which suggests that tool condition had a more prominent influence than feed rate during the latter stages of a test. Surprisingly, increasing the primary feed rate to 0.3 mm/rev did not appear to exacerbate the level of damage compared to results when drilling at 0.1 mm/rev. Similar results and trends were seen with the Type 3 lay-up.
